September 12, 2008

Cal OSHA Document Request Regarding TEL Facility Investigation

INSPECTION RECOMMENDATION

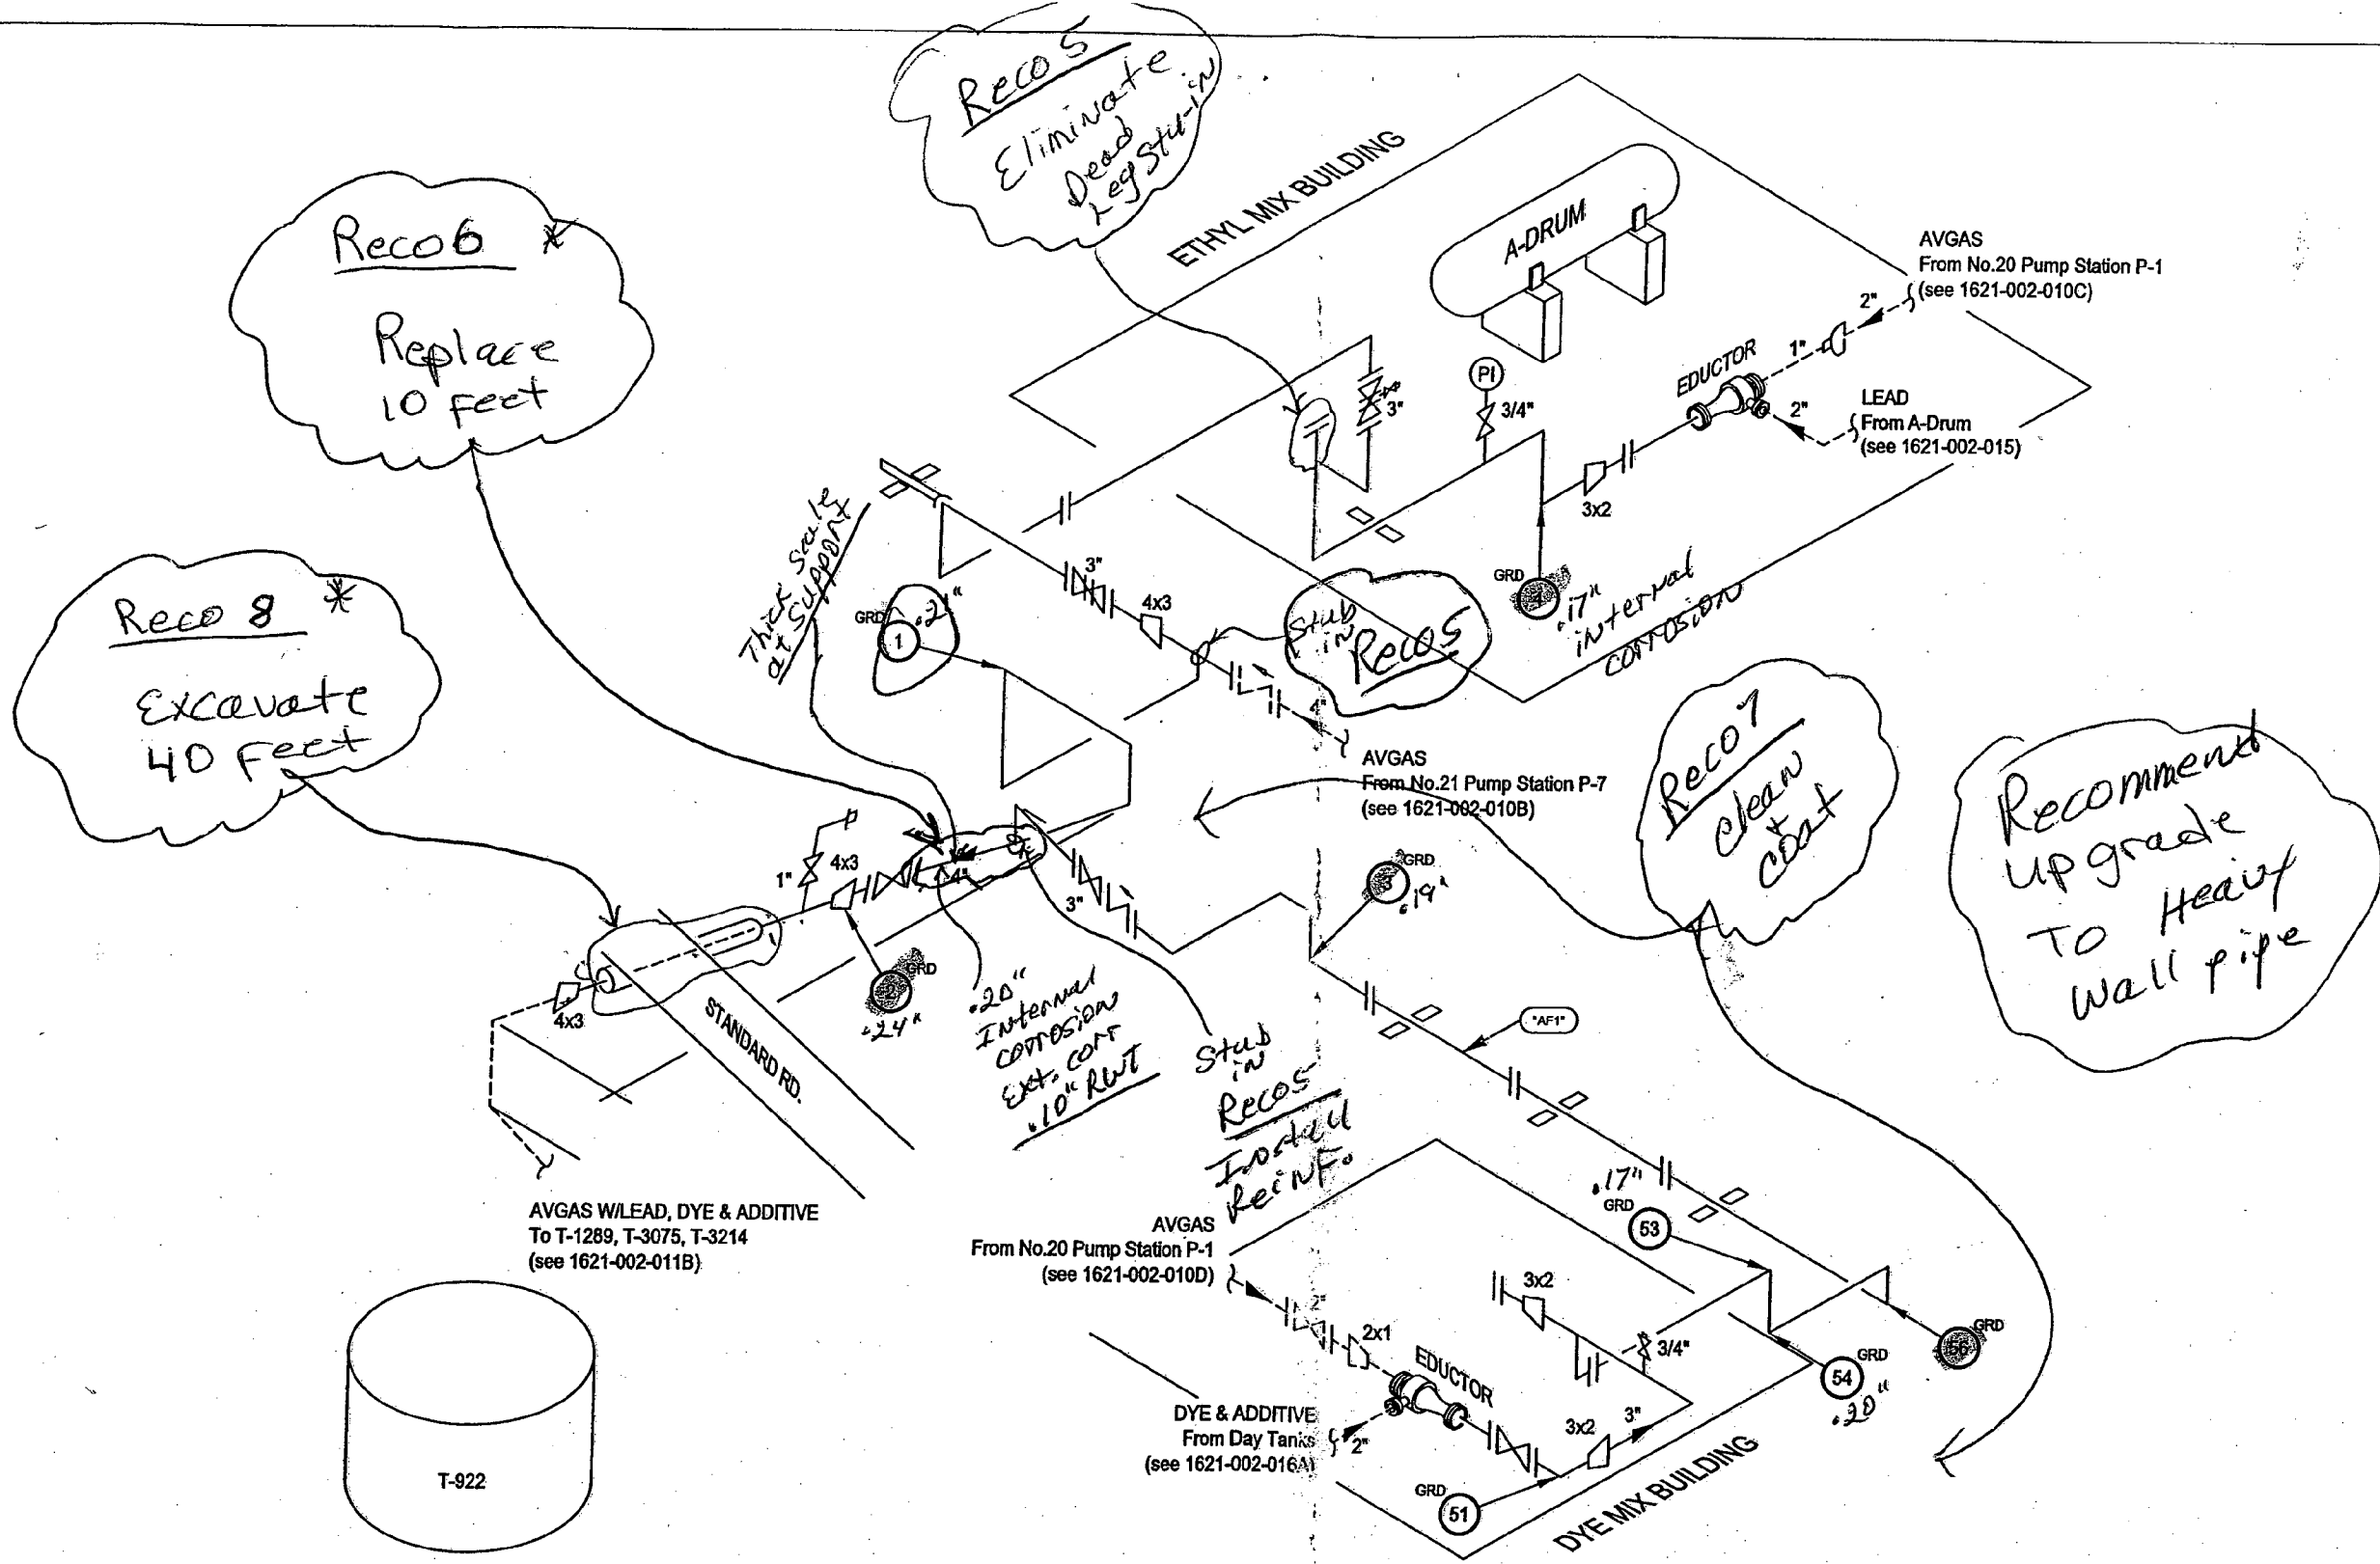
No.1 LEAD LINE

#1 Lead Line Inspection Results. REC-55216					
Information					
<p>The #1 Lead Line was visually inspected and UT gauged for wall thickness per the API-570 10 year requirement. The line is corroding internally & externally. Numerous failed pipe supports were found from below T-3075 over to the Ethyl Mix Building on Standard Rd. approx. 1300 feet: Recommend installing new pipe supports. Due to the failed supports the line has been setting in soil & water causing the external corrosion. The combination of external corrosion and internal corrosion has left an average wall thickness of 0.05 in. (internal & external corrosion) to 0.20 in. (internal corrosion) (throwaway thickness is 0.10 in.) on the bottom side of the line (High probability of failures). Replacement of approx. 800 feet of the pipe is required in several locations. A section of the line is buried under Standard Rd. The condition of the line in this area is unknown: Excavation is required for inspection. Several dead legs, un-reinforced branch connections & mitered joints were also found. It is Inspections recommendation that this line be replaced from the tank to the Ethyl Plant and the pipe schedule be increased to heavy wall. The 3" branch to the dye mix building is corroding under the failed paint, recommend cleaning and re-coating the line. UPDATE 8-28-06; THE DAY LIGHTING & LIFTING OF THE LINE (RECO'S 1 & 2) WERE COMPLETED. ADDITIONAL PIPE REPLACEMENT & AND CLEANING & COATING ARE REQUIRED. REPLACED WORK ORDER #26146385 WITH A NEW WORK REQUEST.</p>

#	Information / Recommendations
	<u>Required Work</u>
	6) Replace approx. 800 ft. of corroded pipe in several locations per ABO pipe class.
	7) Clean & coat several locations per spec. 1.8. Contact inspection after cleaning the line.
	8) Excavate or replace per ABO pipe class one buried location.
	1) COMPLETE: Day light to remove foliage and soil in seven locations, remove one failed rubber sleeve seal to complete inspection.
	2) COMPLETE: Lift the line and block it up for inspection in one location.
	3) COMPLETE: Repair one leaking fitting.
	<u>Recommended Work</u>
	4) Install supports as needed in three locations.
	5) Install reinforcement on two branch connections. Install elbows on two un-reinforced branch connections and eliminate two associated dead legs per ABO pipe class.

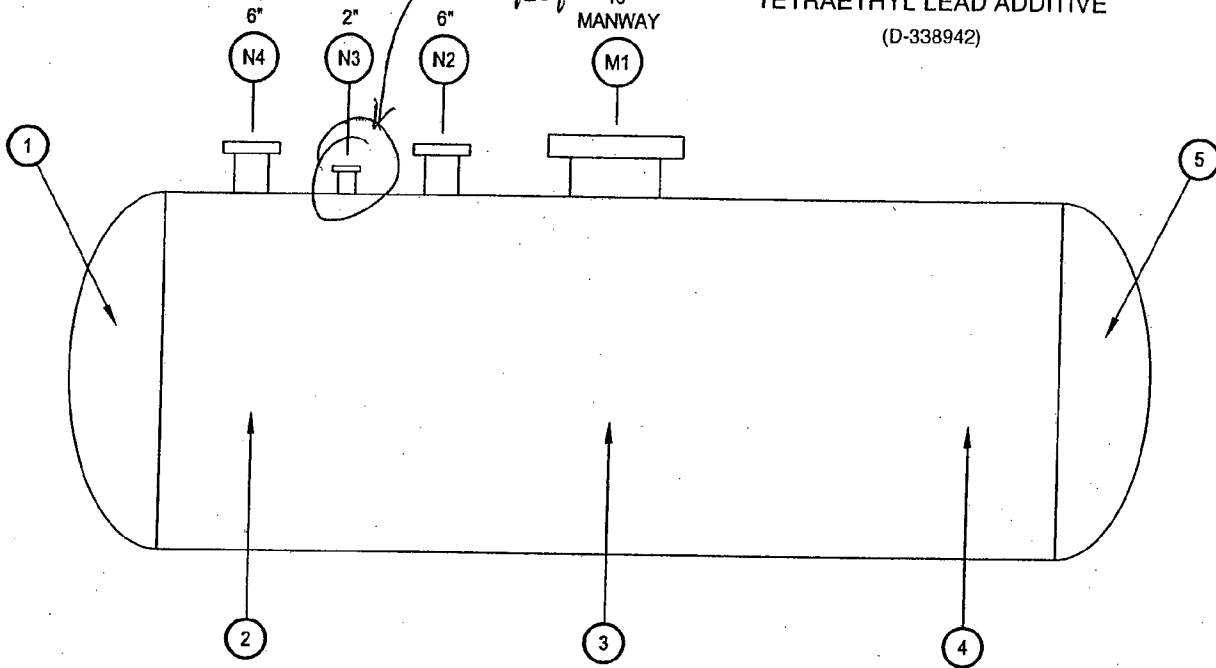
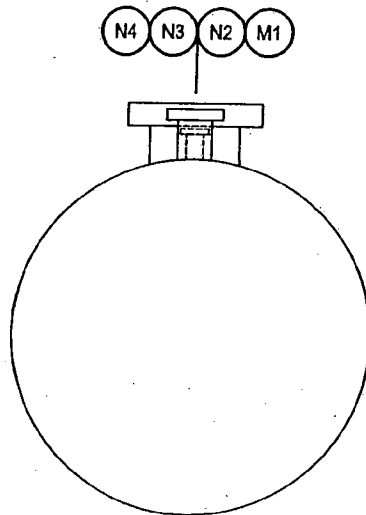
A-DRUM

A-Drum External In Lieu Inspection Results. REC-44234					
Information					
<p><i>The A-Drum was visually inspected & UT scanned. There was no change in the shell wall thickness since the last inspection in 1994. The 18" manway (M1) was UT scanned and found to have a wall thickness of 1.62".</i></p> <p><i>Nozzle #N-2 (6") was radiographed and a wall thickness of 0.43" was found. Nozzle #N-3 (2") was radiographed and has moderate to severe internal corrosion a wall thickness of 0.14" (T-Min is 0.135), replacement is required. The outlet piping is also severely corroded. The radiograph for N-4 (6") revealed the 2" pipe coming off of it also goes through the 6" nozzle into the vessel. The wall thickness for the 6" is 0.47"; the thickness for the 2" is 0.22". The radiographs revealed external corrosion in all the nozzles. The following is a list of required and recommended repairs.</i></p> <p>Required Work:</p> <p><i>1) Replace nozzle N-3 per Engineering specs.</i></p> <p><i>All hot work in this Inspection Recommendation is subject to the "Richmond Refinery - Metal Craft Quality Assurance Procedures Manual;</i></p>

*Rec'd
Replace nozzle
w-3*

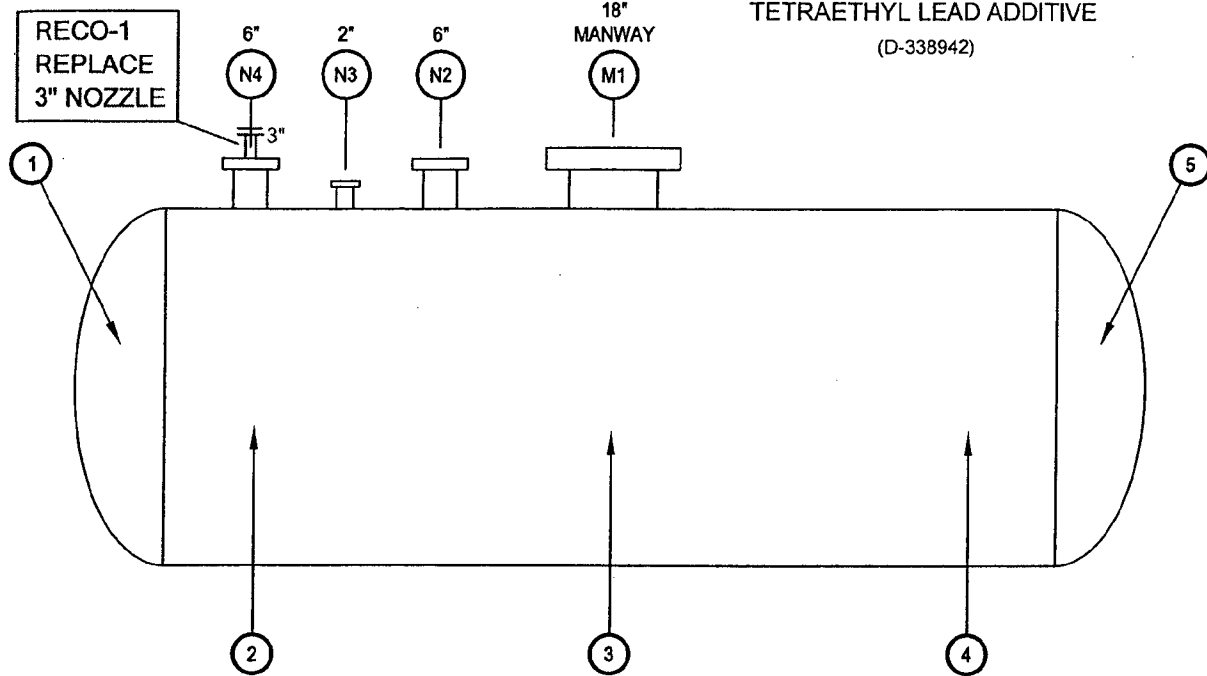
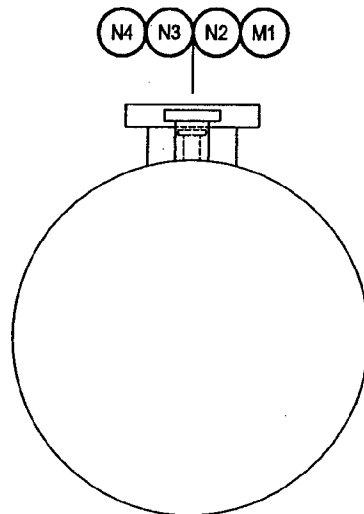
TETRAETHYL LEAD ADDITIVE

Replace failed 3" nozzle on A-Drum. REC-62457					
Information					
The 3" nozzle (3" nozzle drops down through 6" #4 nozzle) on the A-Drum failed at the top weld; Replacement is required. Code weld procedures are required.					
Required Work:					
1) Replace 3" nozzle (N-4) per Engineering specs.					
See ISO markup on M-Drive "A-DRUM 3IN NOZZLE" for repair location.					
All hot work in this Inspection Recommendation is subject to the "Richmond Refinery – Metal Craft Quality Assurance Procedures Manual;					
Cost Estimate by:	Total Man-Days	Cost per Man-Day	Total Labor Cost:	Total M'trl. Cost:	Total Cost:
Estimator

Replace failed 3" nozzle on A-Drum.
REC-62457
filed 6/2007

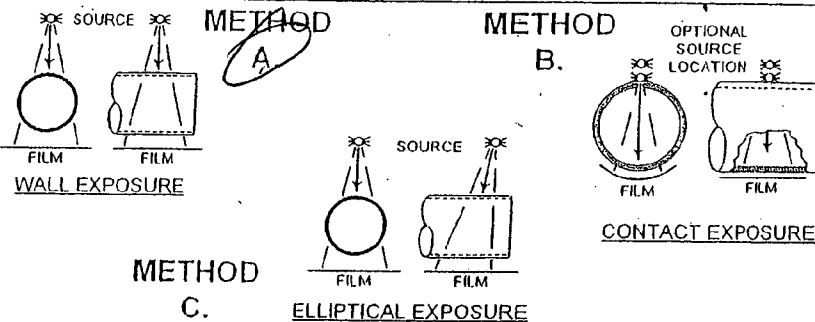
Perform RT. per - S. Tyree
 on N-2, 3 & 4 - Also D.I. Small
 bore piping.
 Deposits & Corrosion in
 all locations.
